ROAD NEEDS STUDY

TOWNSHIP OF BLIND RIVER

July, 2014

Project No. 14-149

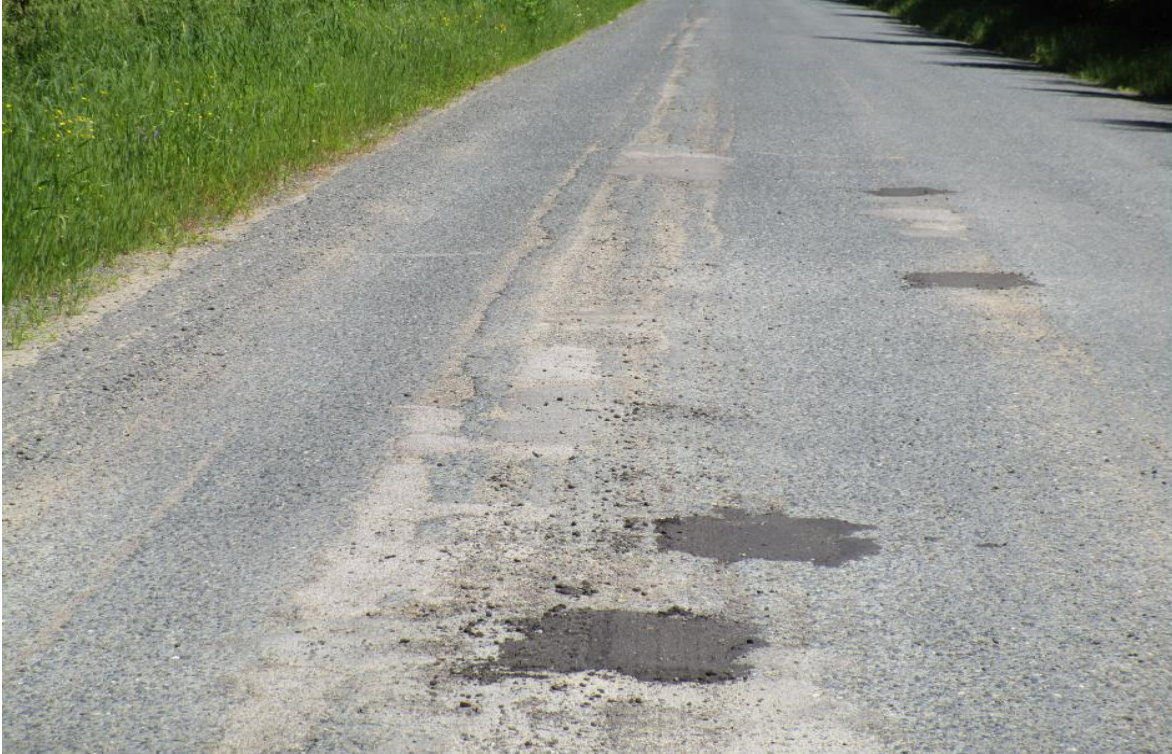
Pine Drive: Distortion, Ravelling and Cover Aggregate Loss

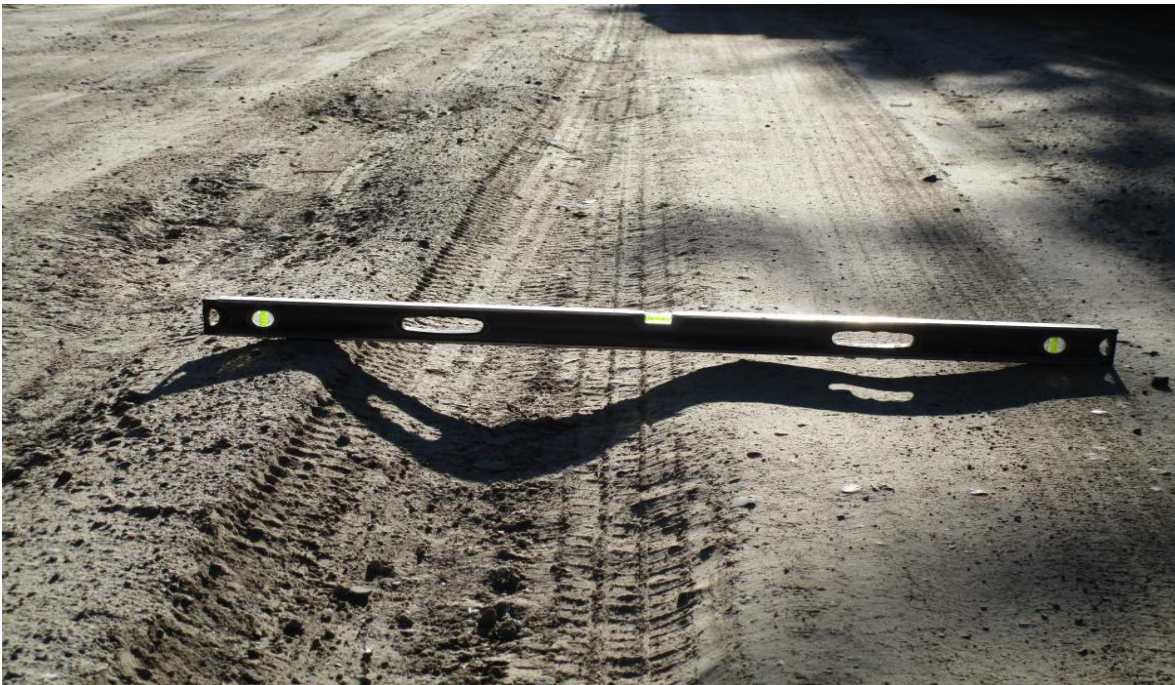
Boom Camp Road: Rutting, Washboard and Loose Gravel

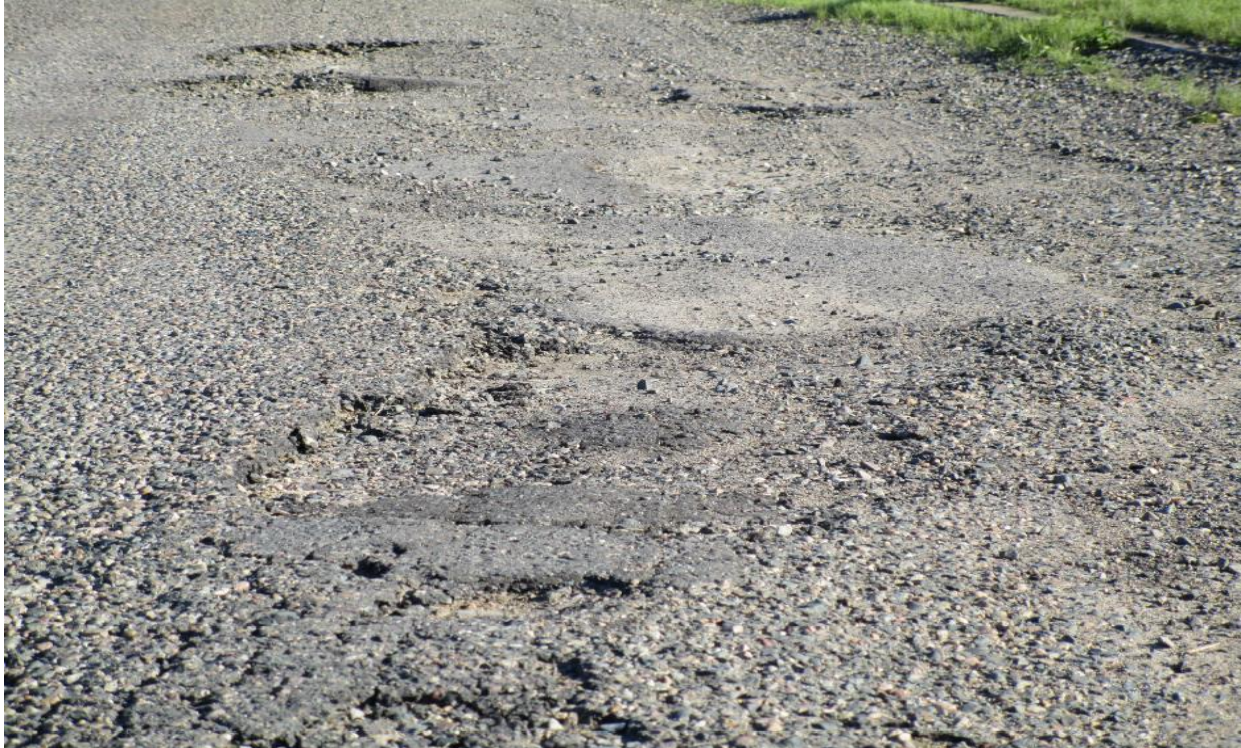
Marina Road: Distortion, Pavement Edge Cracking and Cover Aggregate Loss

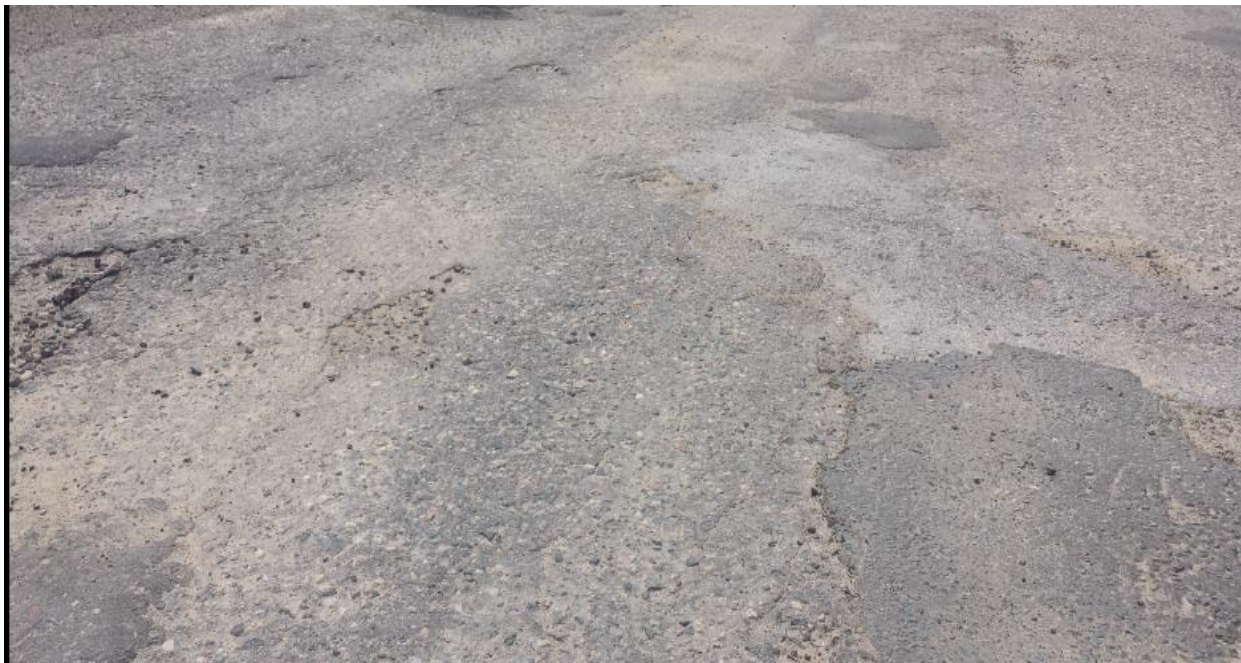
Magog Lake Road: Distortion, Ravelling and Center Line Cracking

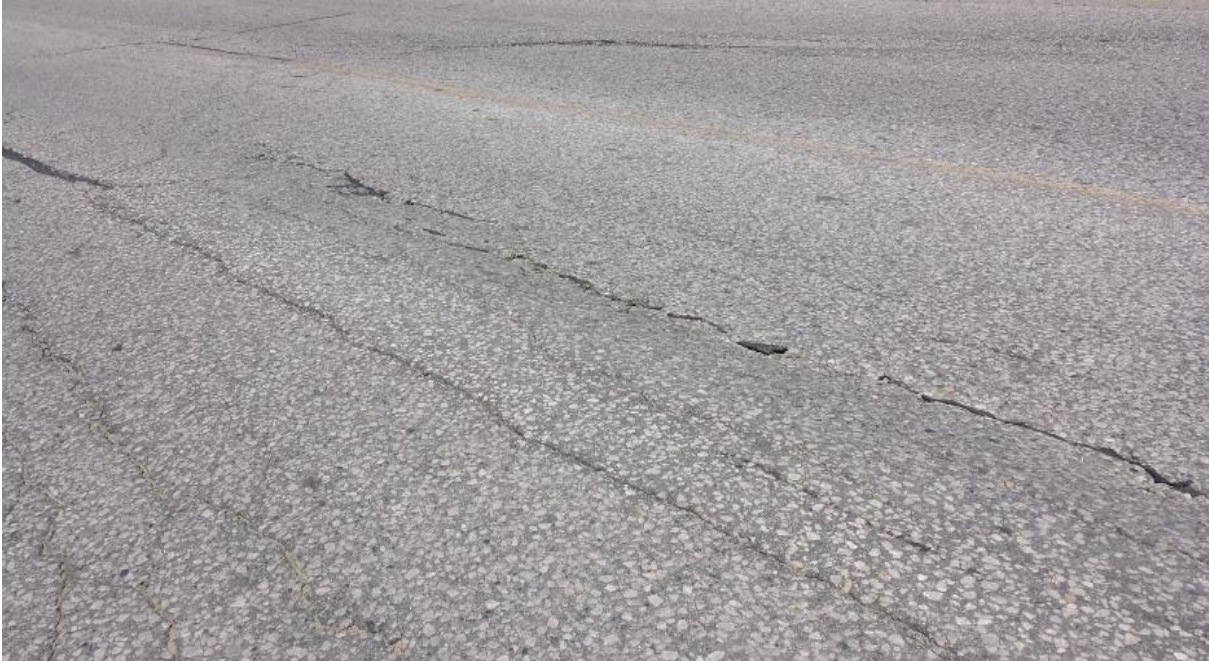
Robb Road: Rutting, Map Cracking and Longitudinal Cracking

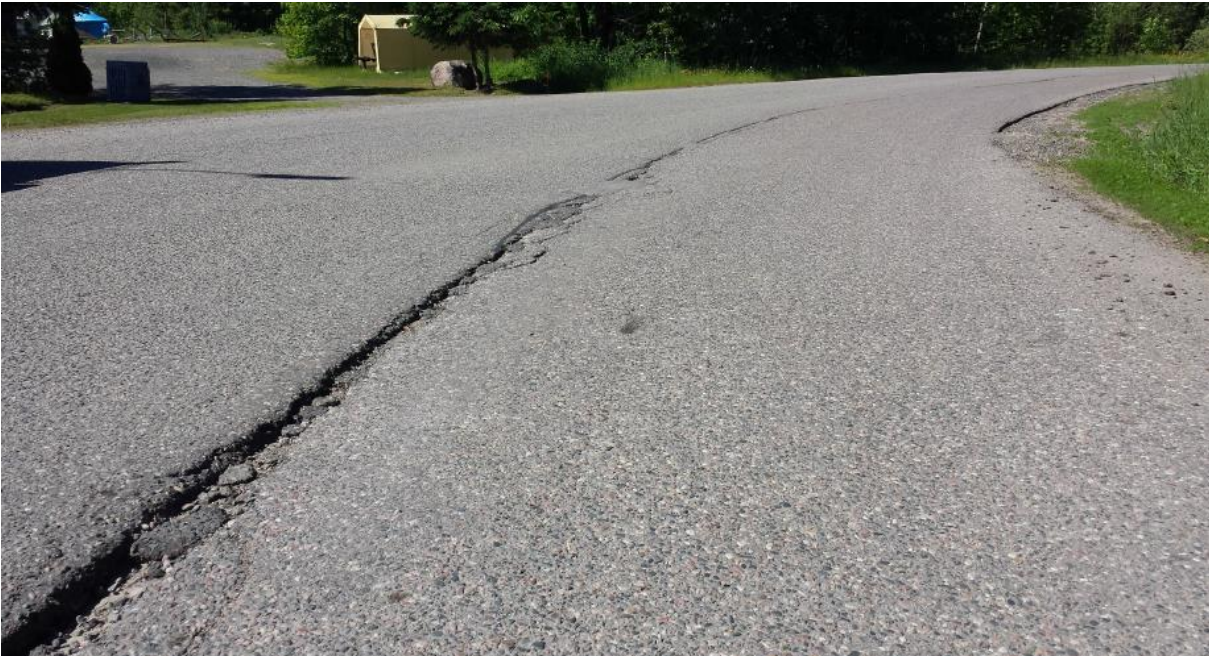
Robb Road: Severe Center Line Cracking

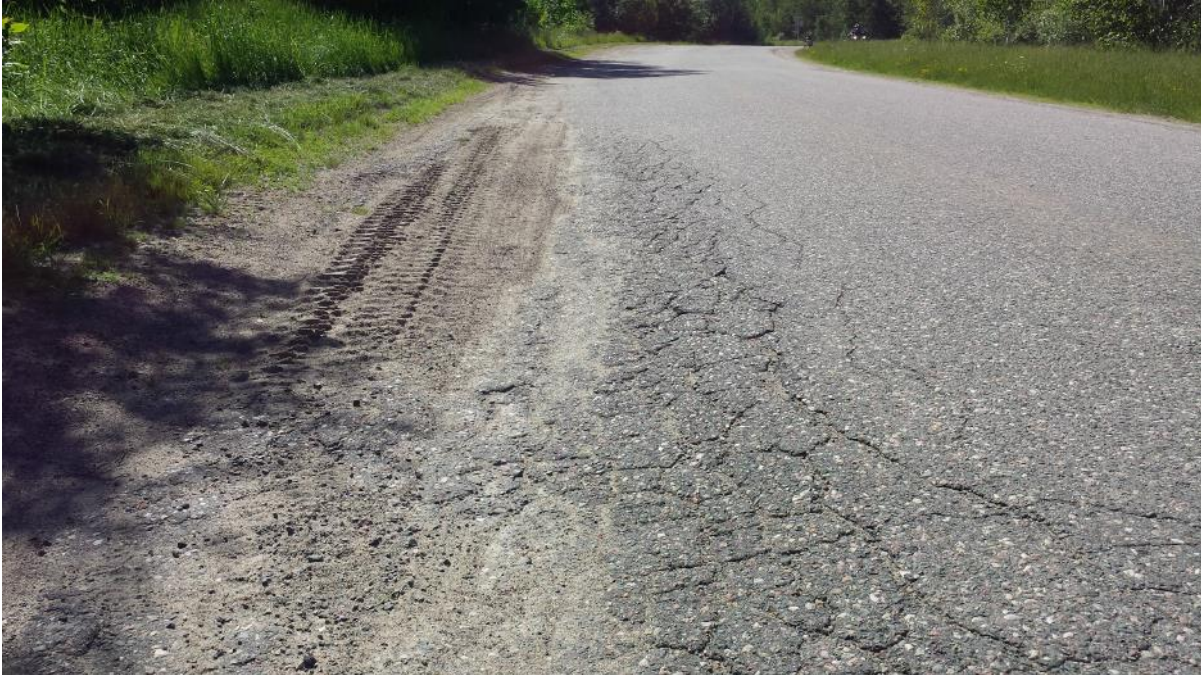
Schurm Avenue: Pavement Edge Alligator Cracking

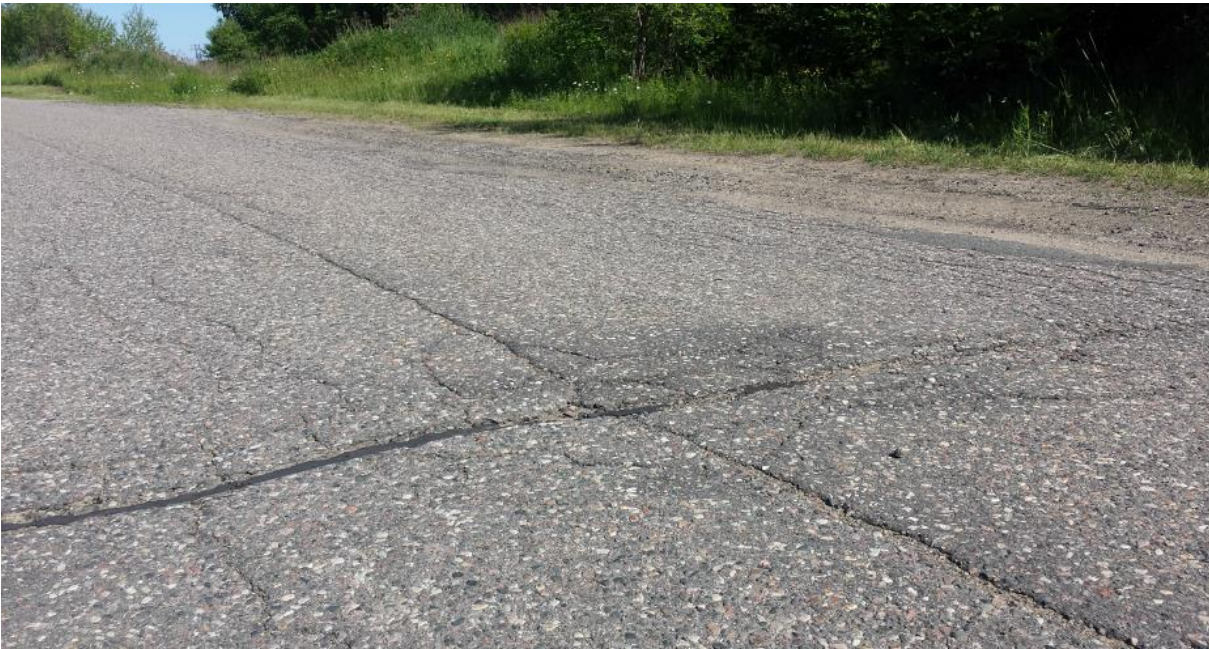
Birch Street: Ravelling, Longitudinal and Transverse Cracking

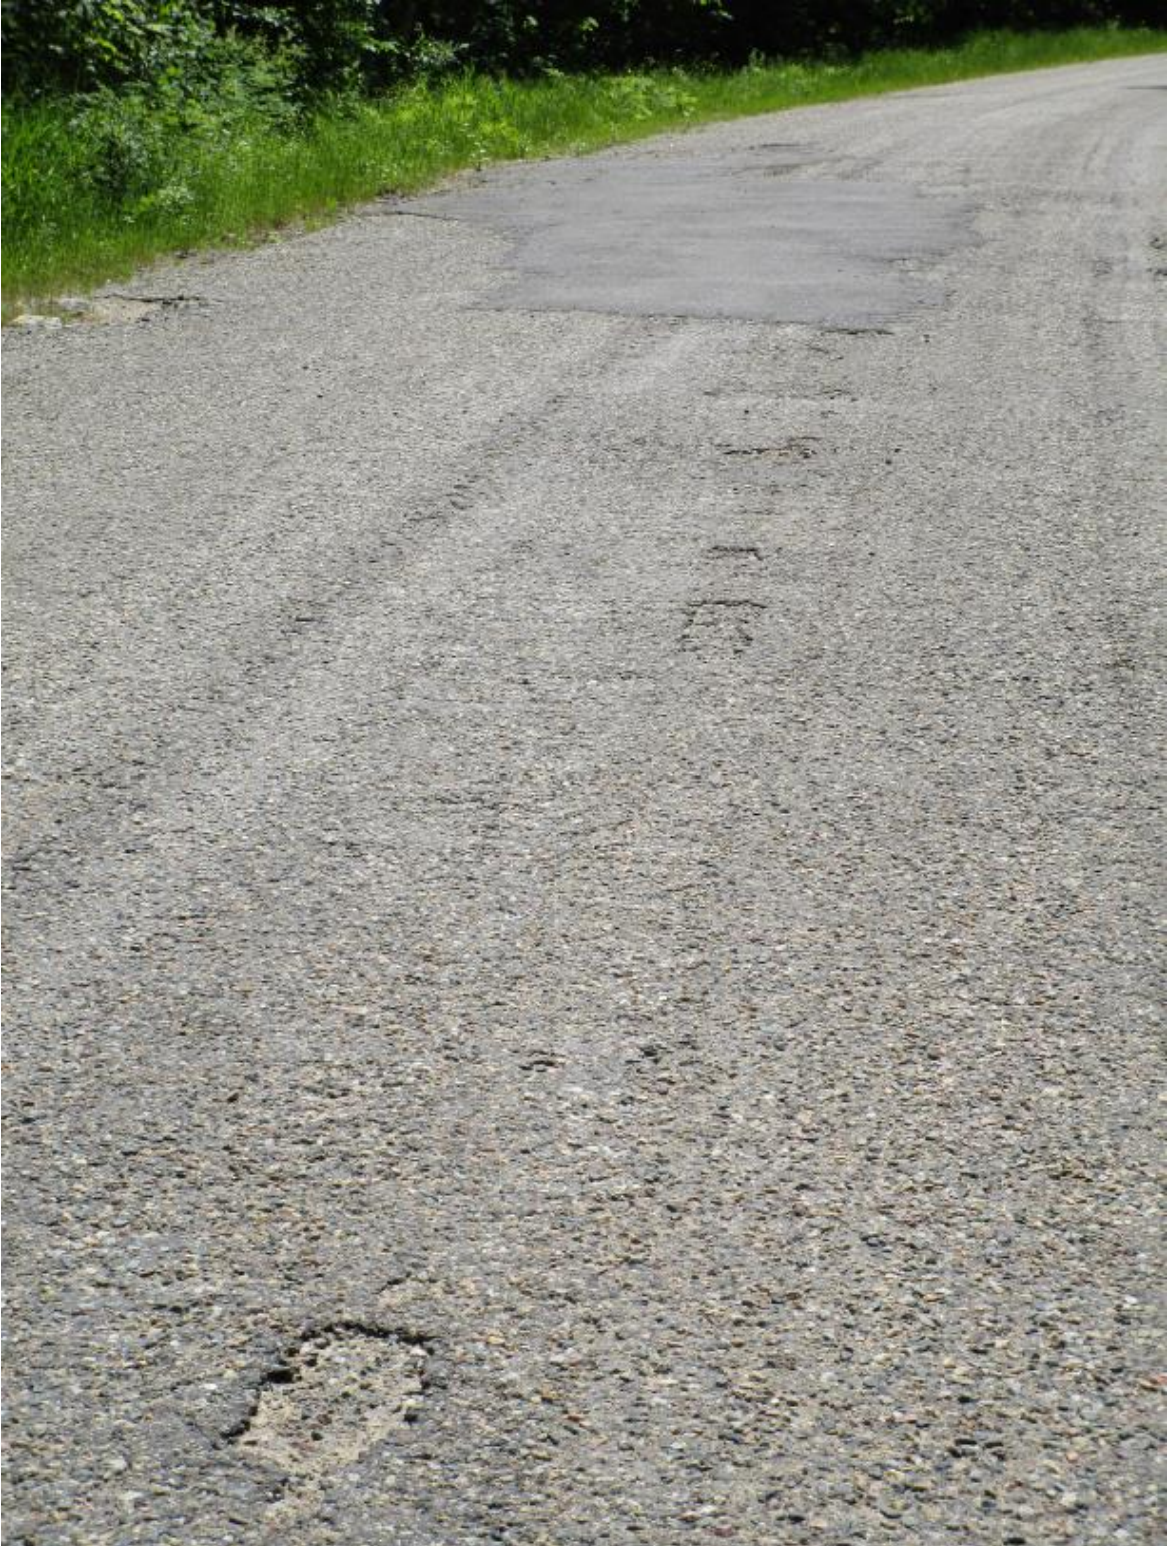
Old Steel Road: Ravelling and Cover Aggregate Loss
